NATIONAL DAM SAFETY PROGRAM. SOUTH RIVER NUMBER 6 (ID VA-01509)--ETC(U)

Name of Dam: South River No. 6

Inventory Number: VA 01509

PHASE I INSPECTION REPORT
NATIONAL DAM SAFETY PROGRAM

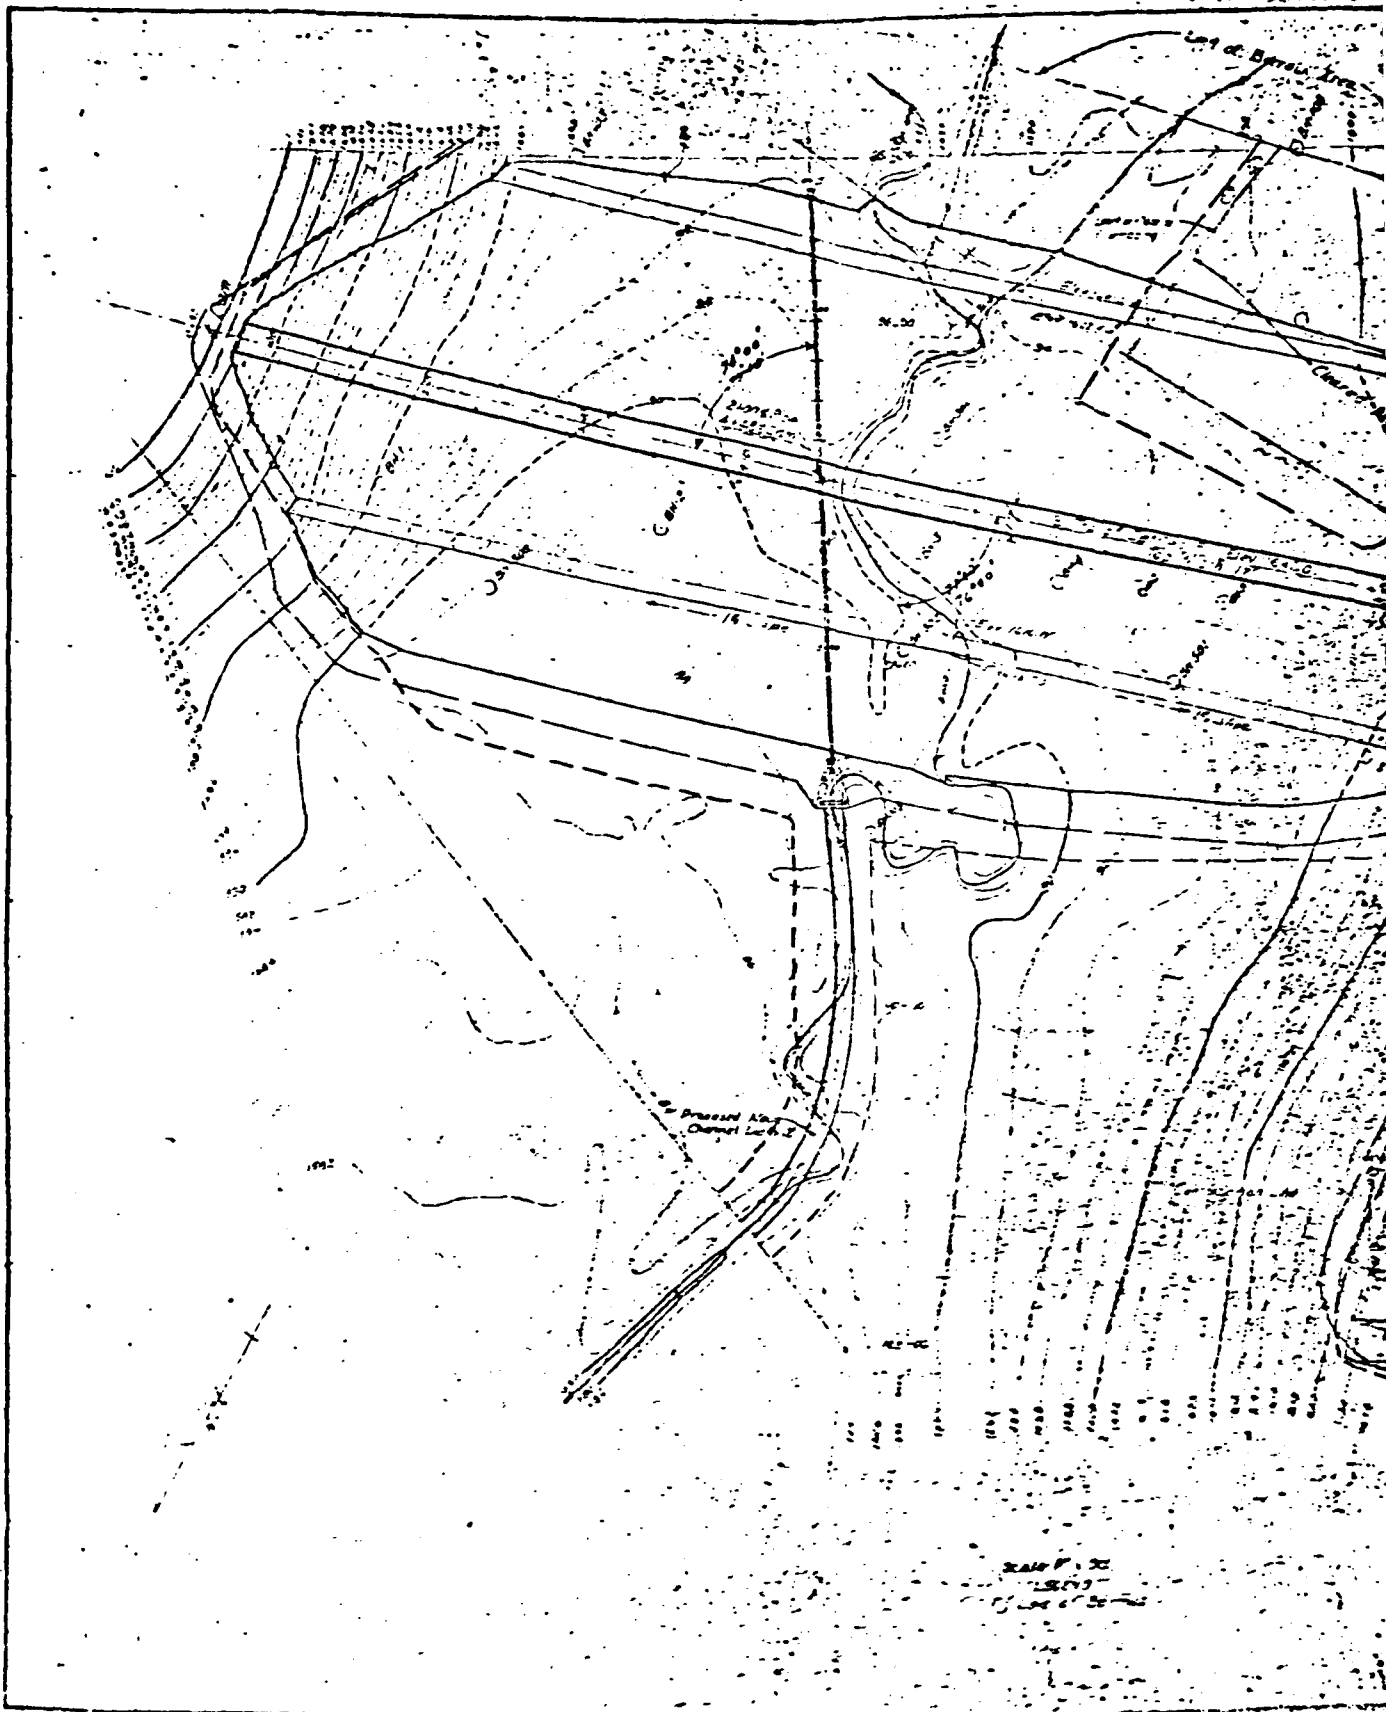
NOTE:
BENCH ON DOWNSTREAM EMBANKMENT TILTS BACK TOWARD THE EMBANKMENT —
STANDING WATER PRESENT IN TROUGH ON BENCH
MANY MOLE BURROWS / TRACKS PRESENT ON DAM
